Materials for Advanced Turbine Engines

Project Completion Report Project 2

René 150 Directionally Solidified Superalloy Turbine Blades

Volume II

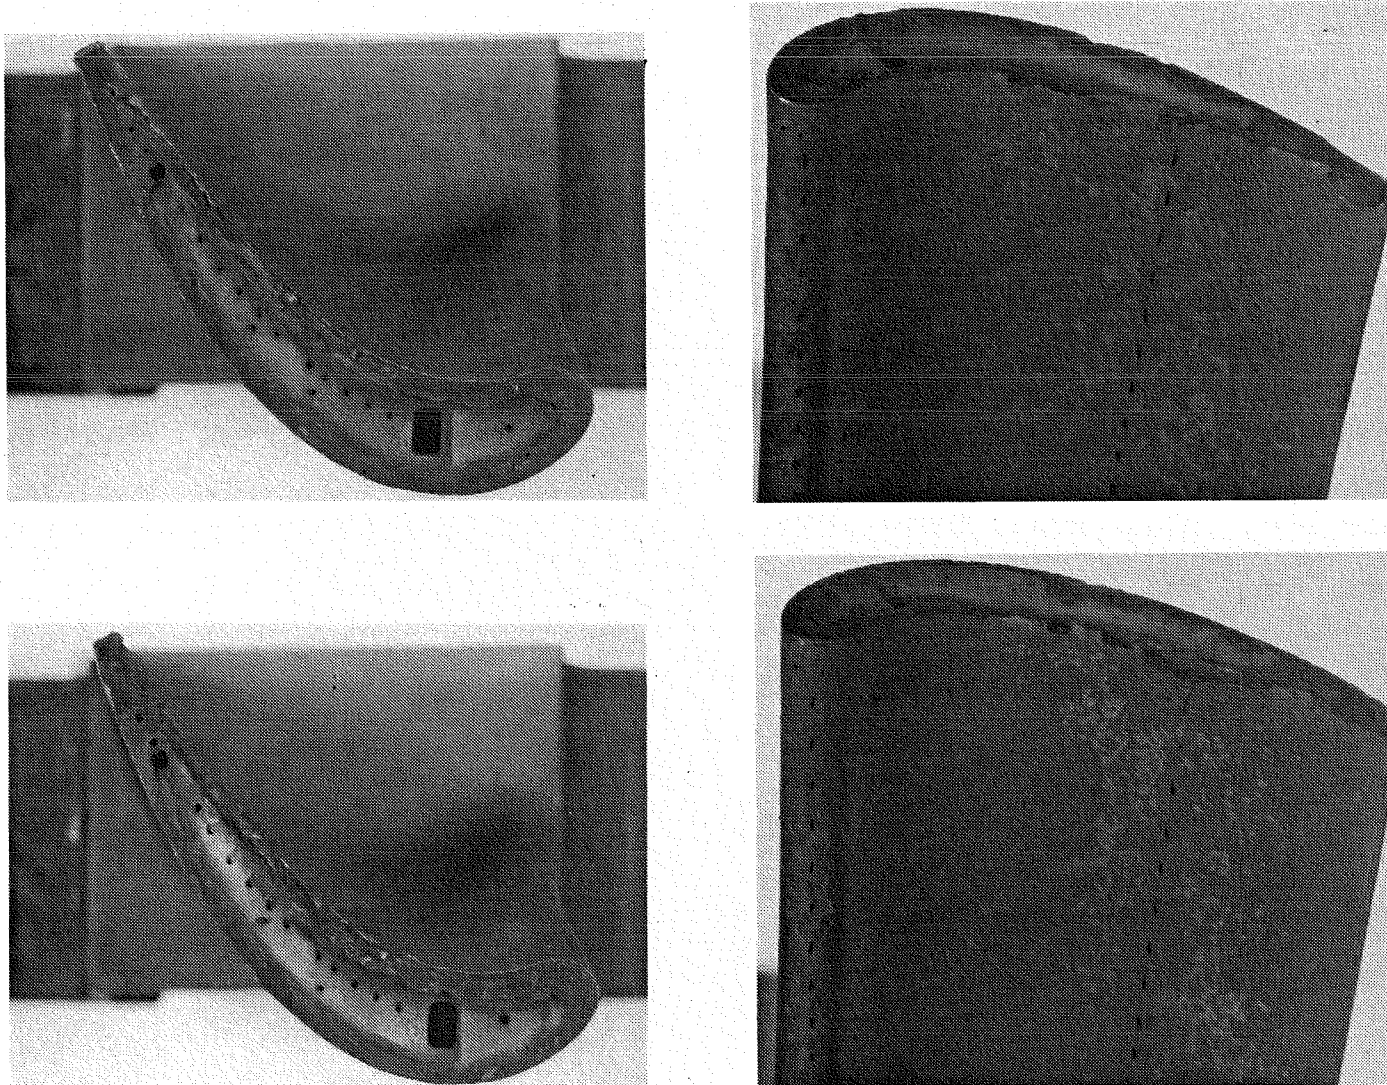
Figure 10. Typical René 150 HPT Blade Tip After 1000 "C" Cycle Engine Test.

As expected, the René 150 blades exhibited much more tip oxidation than the René 80 blades. Figure 10 illustrates the extensive metal loss that occurred on the René 150 blades and left the coating in relief in a worst-case situation. In addition, the René 150 blade platforms and shanks were oxidized on the pressure side of the blade. The René 80 blades exhibited no oxidation in this region. The AC 402 blade coating showed no obvious signs of distress.

The fan engine test was successfully run, and the René 150 HPT blades operated at the desired 56° C (100° F) temperature increment above the René 80 blades; however, the posttest analysis of the blades revealed several potential long-term problems with the blade design utilized in this project. A long-life blade design would have to be coated on the inside and outside including the shank and dovetail regions. In addition, an oxidation-resistant tip would be required.

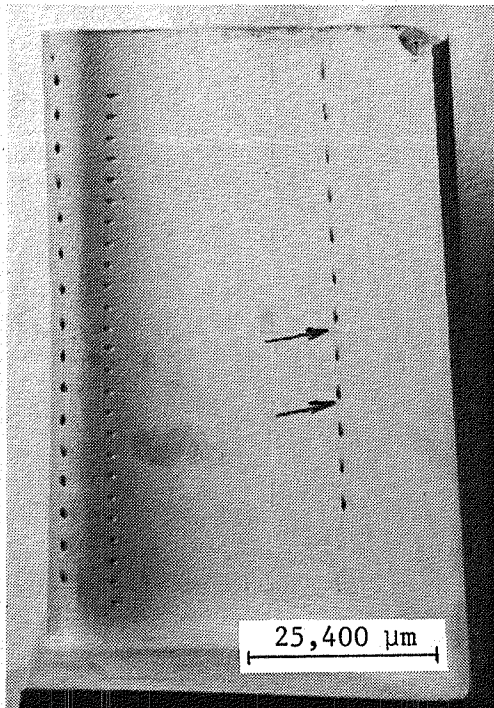
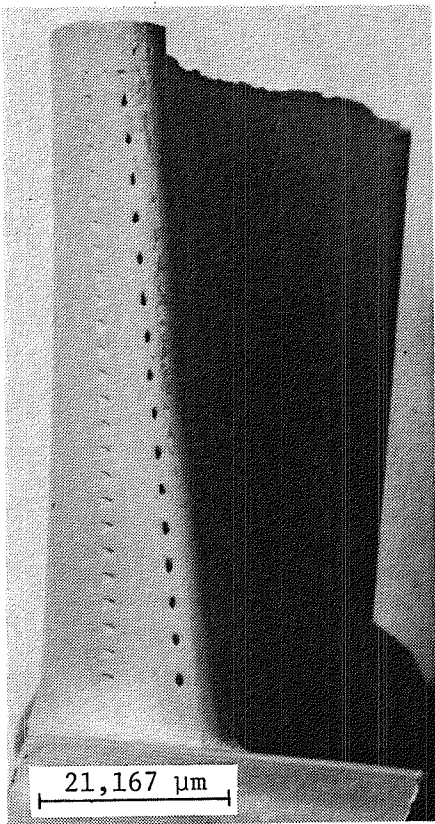
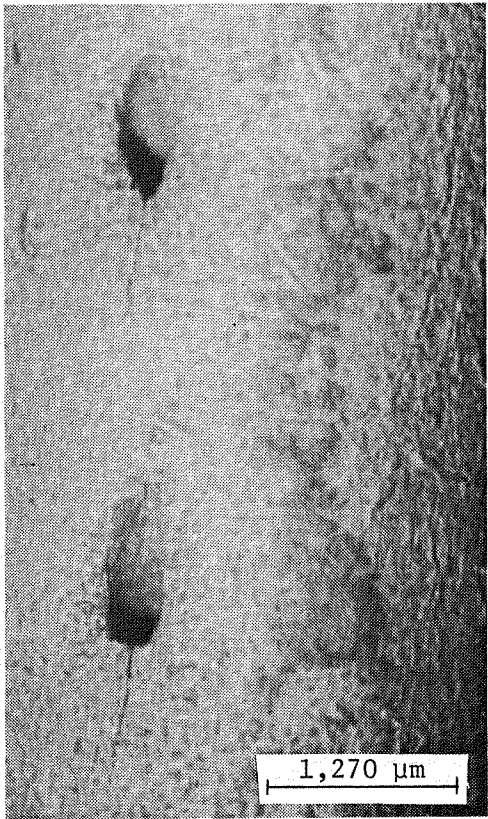
Figure 11. Nose-Hole and Pressure-Side, Film-Hole Cracking.

All of the blades in the rotor contained radial cracks emanating from the nose, concave film and concave gill holes; however, the cracks in the René 150 blades were more frequent and extensive. Table II presents the cracking summary for the René 150 HPT blade. Figures 11, 12, and 13 show typical examples of the observed cracking. The René 150 and the René 80 blades exhibited similar platform cracking in terms of location and extent. Several examples of this are shown in Figures 14 and 15. The dovetail wear patterns were similar on both the René 150 and René 80 blades.

Concave - Note Cracks at Pressure Side Holes

Leading Edge

Leading Edge Hole Cracks

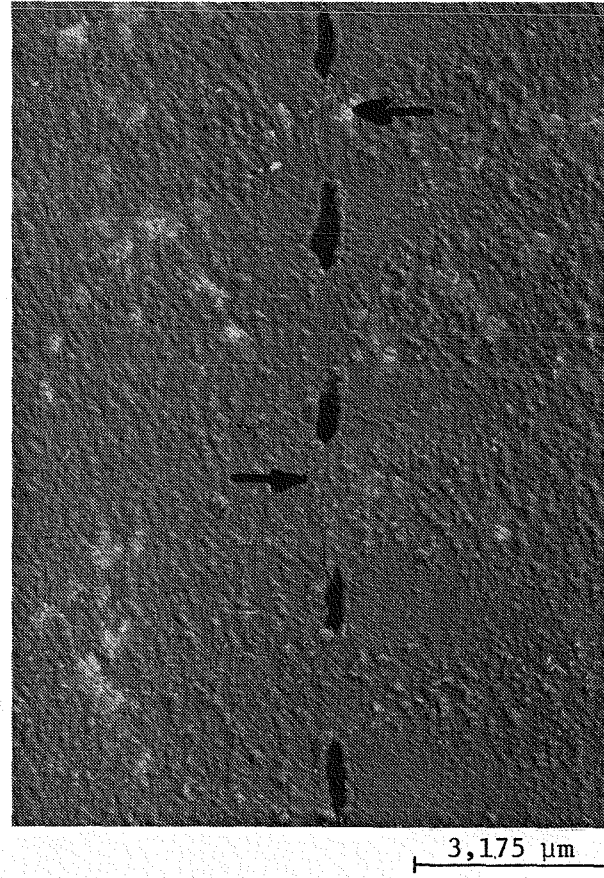
Figure 12. Typical Radial Cracks at Pressure-Side, Film-Cooling Holes.

3. Pressure-Side Film Holes	All 13 blades exhibited radial cracking. Holes below No. 8 generally cracked from top and bottom of hole; above No. 8 cracked from bottom only. Total number of cracked holes varied from 7 to 12. Six blades had two or more holes connected by cracks, and these were found between holes 5 to 8 only.

Metallographic evaluation of the cracks observed at the nose holes, concave cooling holes, and in the platform showed that they were typical thermal-fatigue cracks. They were characterized by a predominantly transgranular crack path and associated oxidation and alloy depletion as shown in Figures 22, 23, and 24. A fractographic evaluation of several of the cracks was performed by breaking open the blade and examining the fracture surface with a scanning electron microscope (SEM). Even though the crack fracture surfaces were heavily oxidized, it was possible to observe evidence of fatigue propagation near the crack extremities as shown in Figures 25 and 26. The airfoil cracks did not extend through the wall thickness in any location. The platform cracks extended completely through the platform edges. These exhibited less alloy depletion and oxidation than the airfoil cracks (indicative of a lower operating temperature).

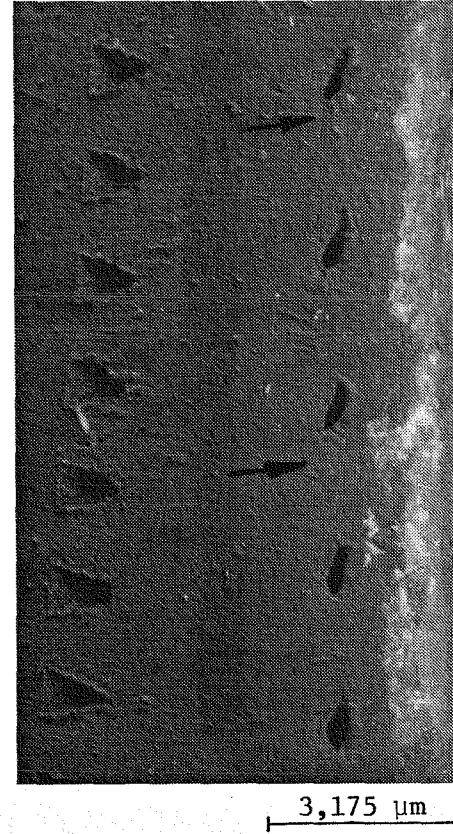
Figure 13. Typical Radial Cracks at Leading-Edge Nose Holes.

Location	Cracking Observed
1. Leading-Edge Nose Holes	All 13 blades exhibited radial cracking in convex row of nose holes. Total number varied from 5 to 16 cracks with the most severe cracks between holes 8 to 12. Two blades had a cracked hole in the concave row.

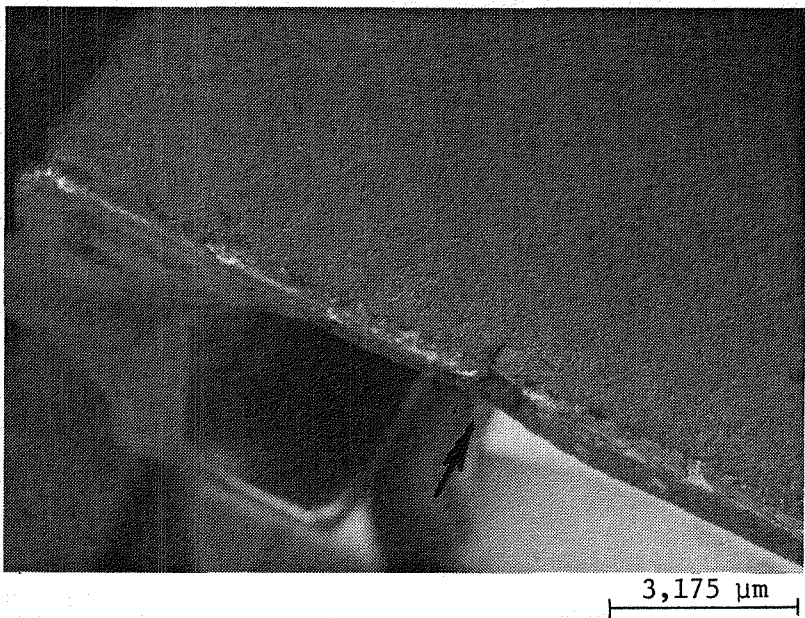
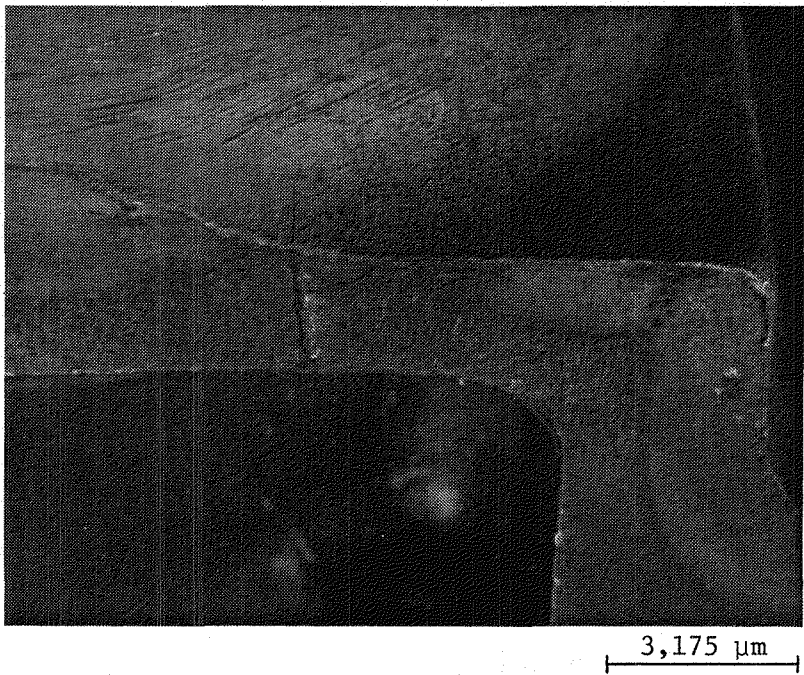
Figure 14. Platform Cracks.

4. Suction-Side Gill Holes	No apparent cracking.
5. Platform	Ten blades contained cracks on the convex side platform. Six blades were cracked just forward of the high C location and four just aft. On seven of the blades, the cracks extended to the airfoil fillet radius.

Platform Crack on Concave Side Near Leading Edge

Platform Crack on Convex Side Near Leading Edge

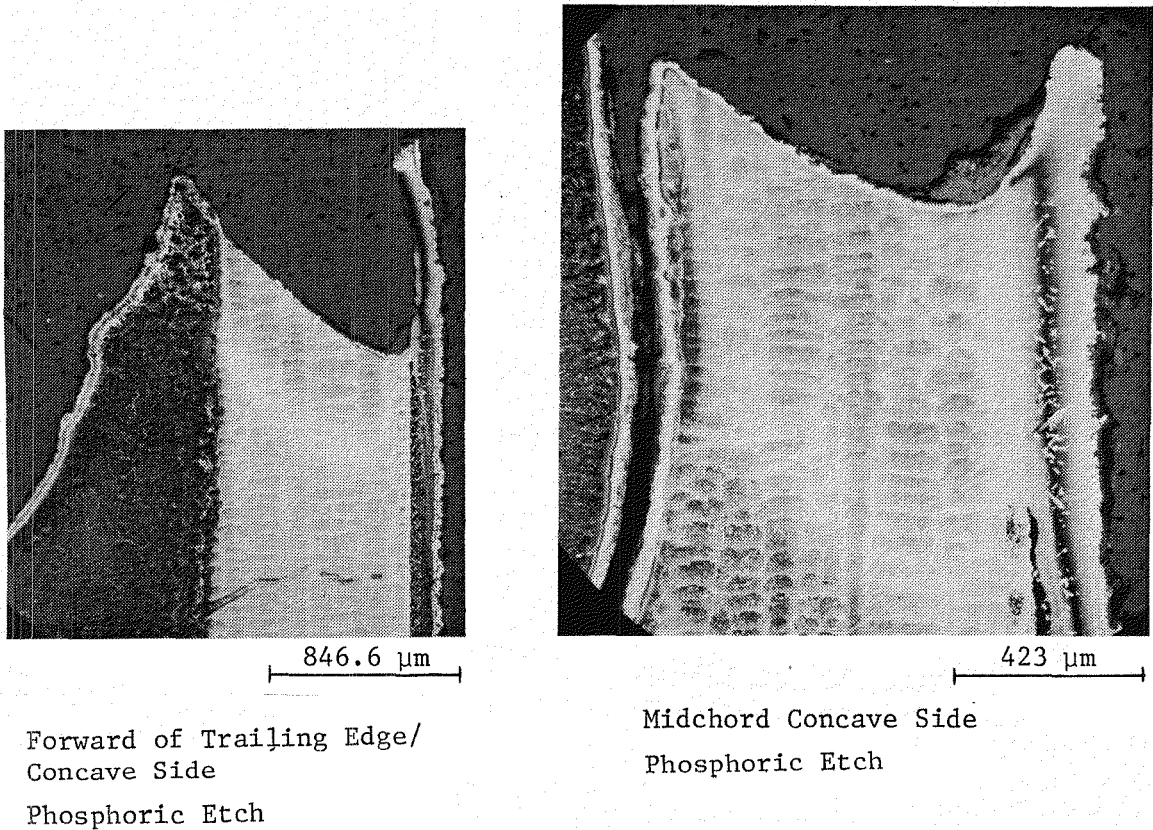
Figure 16. Typical Photomicrographs of Tip Oxidation.

The tip oxidation progressed radially downward from the tip, Figure 16, and was present on all tip sections. It was heaviest on the concave side of the blade near the trailing edge where it reached apparent depths of 40 mils or more. The oxidation was usually most extensive nearest the blade external surface and did not entirely consume the coating.

Forward of Trailing Edge/
Concave Side
Phosphoric Etch

Midchord Concave Side
Phosphoric Etch

(Note That Coating on External Surface is in Relief)

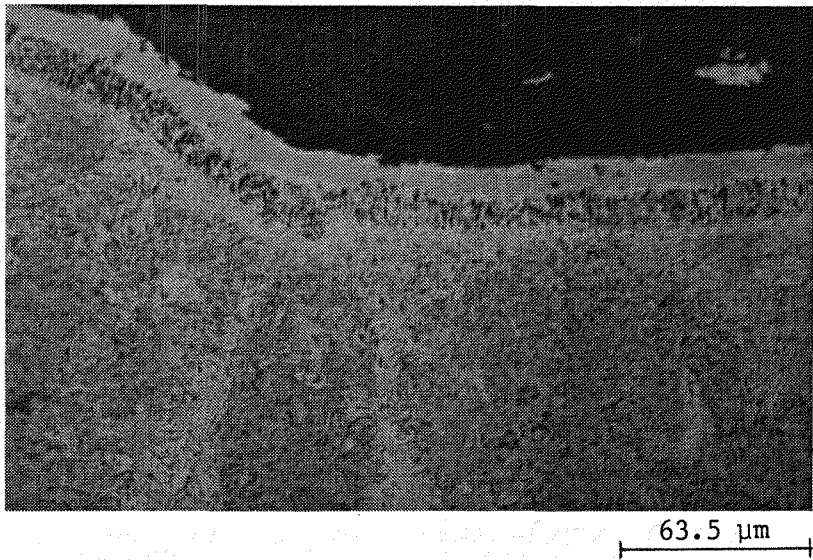
Figure 17. Internal Blade Surface with Aluminide Coating.

The internal blade surfaces that were aluminide, as a consequence of the coating operation exhibited no base-metal attack and minimal coating attack as shown in Figure 17. However, the uncoated internal surfaces were oxidized to various degrees as shown in Figure 18. The heaviest oxidation, approximately 3 mils deep, was observed in the concave side midspan/midchord area of the blade.

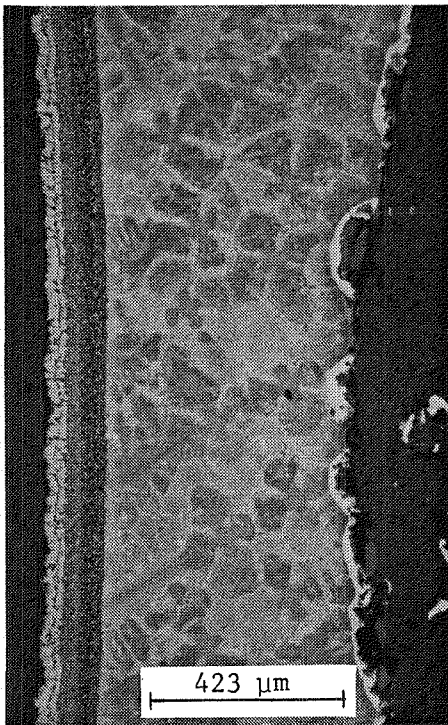
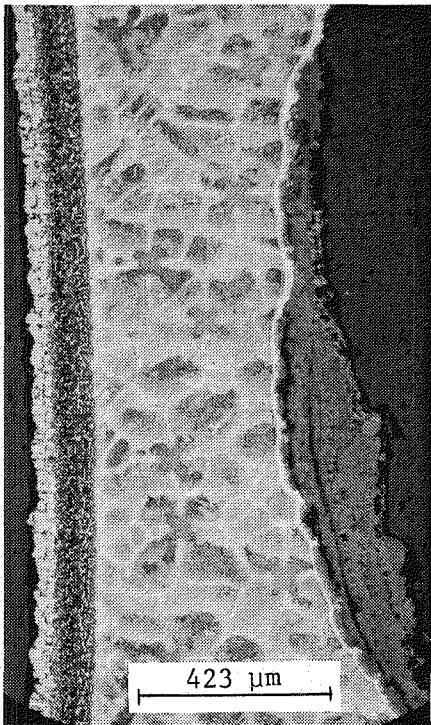
Figure 18. Uncoated Internal Blade Surface.

Concave/Tip Area

Concave/Midspan

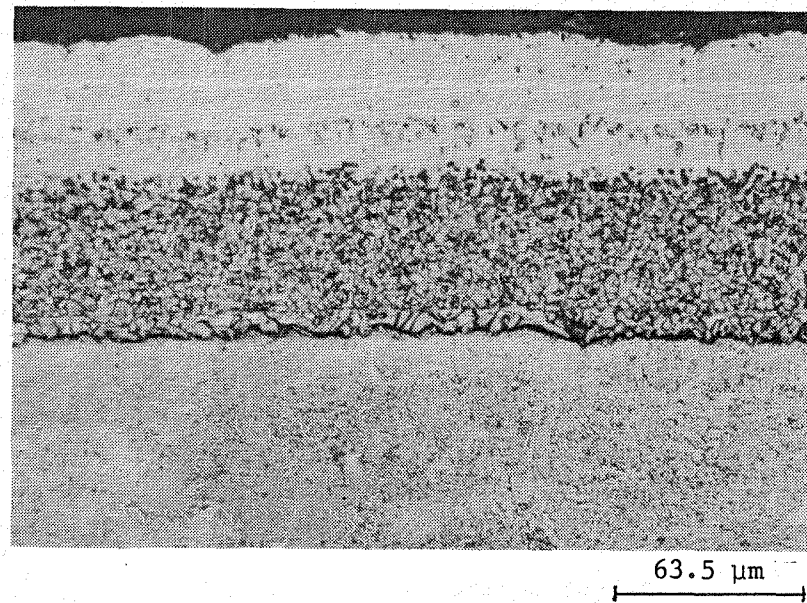
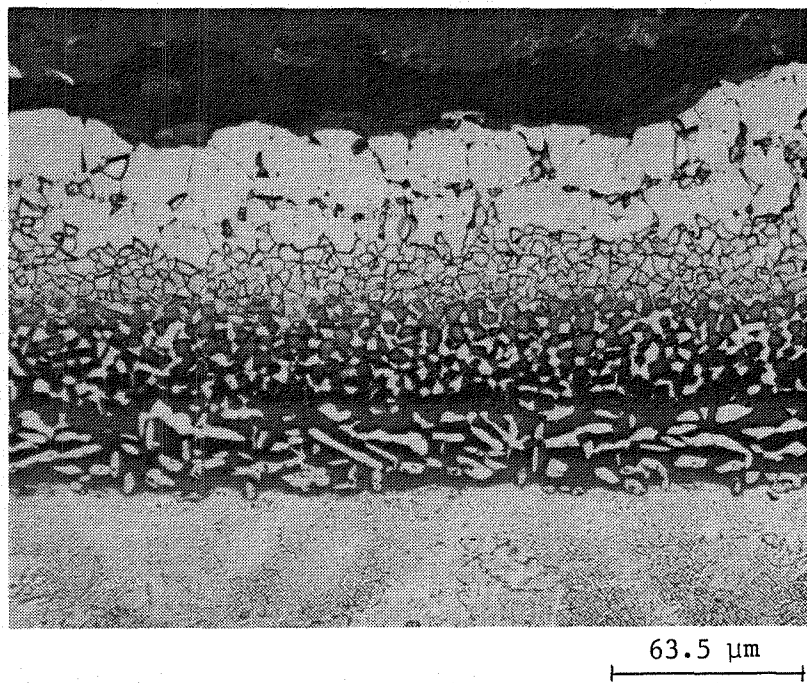
Figure 19. Upper: Typical AC402 Coating in Cooler Regions
Lower: AC402 Coating in Intermediate Temperature Regions.

The AC 402 coating was in generally good condition with a typical thickness of 3 to 4 mils. The airfoil operating temperature was characterized by the pattern of coating changes as shown in Figures 19 and 20. The hottest regions of the blade exhibited the more extensive coating transformation; the coolest regions exhibited negligible transformation. No coating/base-metal separations were evident. Aside from the slight surface oxidation and tip attack discussed previously, there was no significant environmental attack of the coating.

(Note Transformation to γ Particularly in Inner Layer and Increase in Coating Thickness Due to Diffusion).

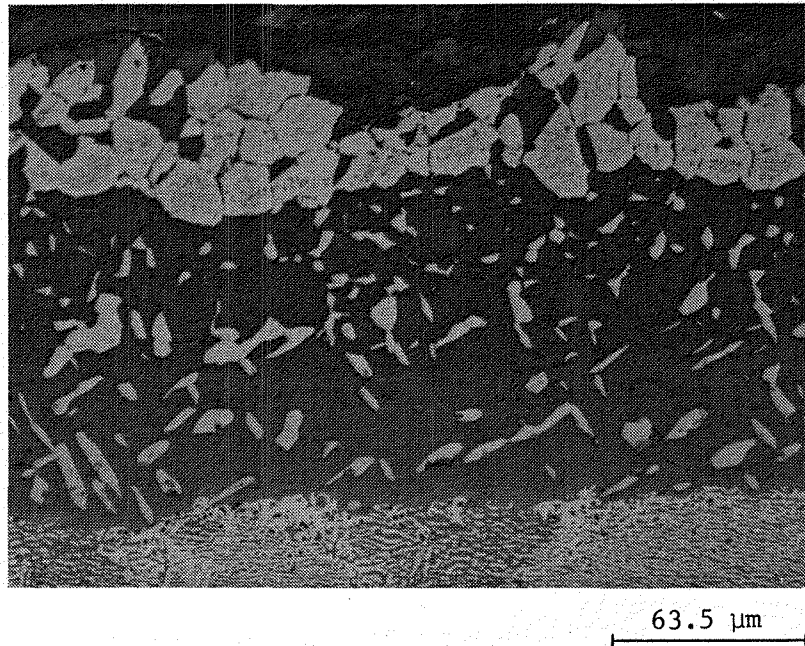
Figure 20. AC402 Coating in Hottest Regions.

(Note Significant Transformation to γ and Increase in Thickness).

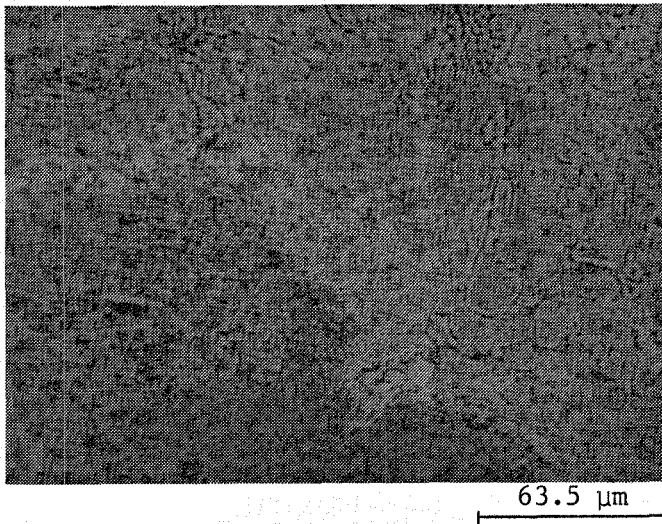
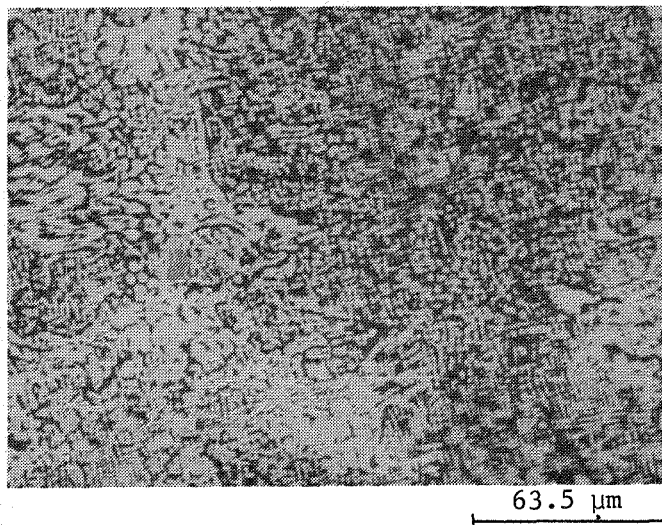
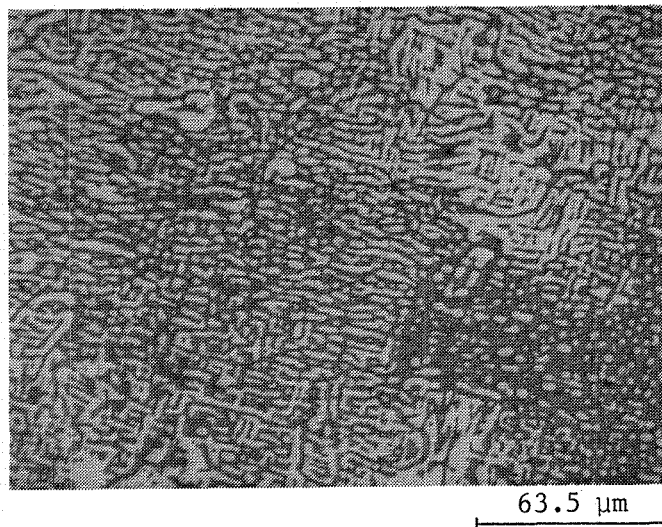
Figure 21. Rene' 150 Base Metal Gamma Prime
Morphology As A Function of Increasing
Temperature.

The actual base-metal temperatures attained during the test were not determinable; however, a microstructural pattern was observed in the René 150 which was consistent with that described for the coating. As shown in Figure 21, the hottest regions of the blade exhibited the coarsest γ' , and the coolest areas exhibited normal γ' size and morphology.

Normal γ'

Coarser γ' (Concave - Midchord/
Trailing Edge, Mid-Span to Near
Tip and Convex - Tip/Trailing
Edge Area)

Coarsest γ' (Concave - Midchord/
Trailing Edge Area)

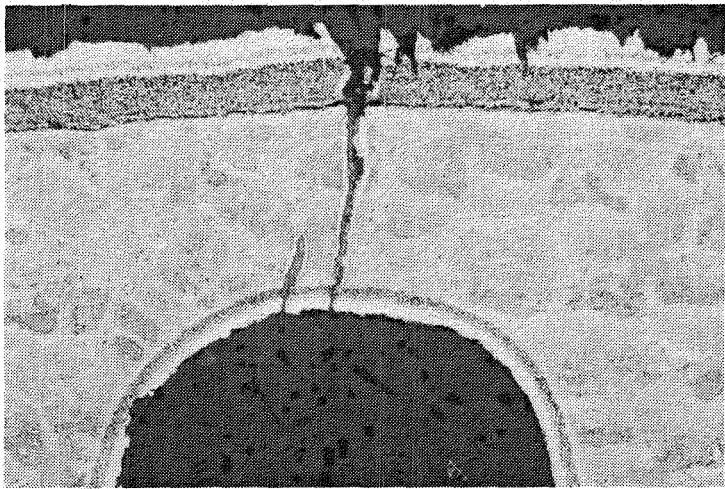
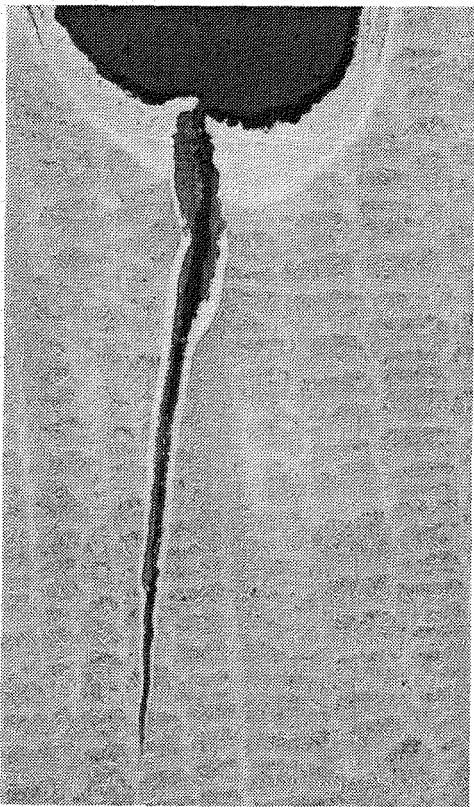
Figure 23. Radial Leading Edge Nose Hole Cracks;

Transverse Section
Phosphoric Etch

Radial Section

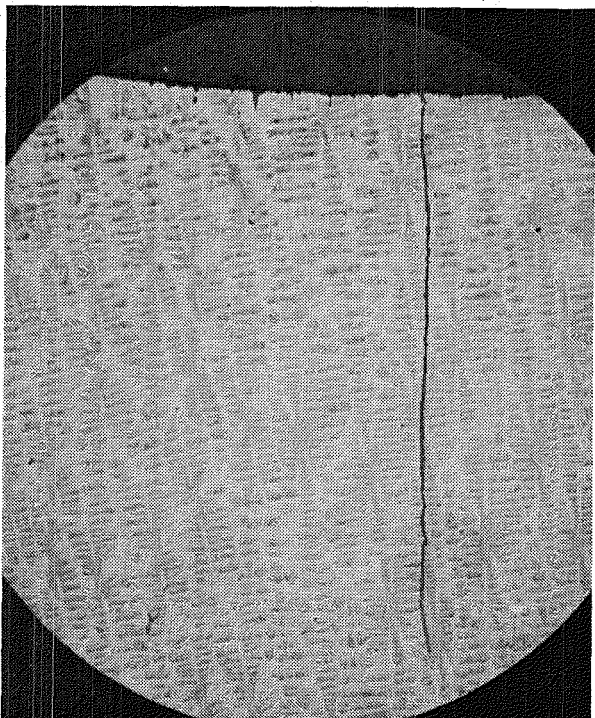
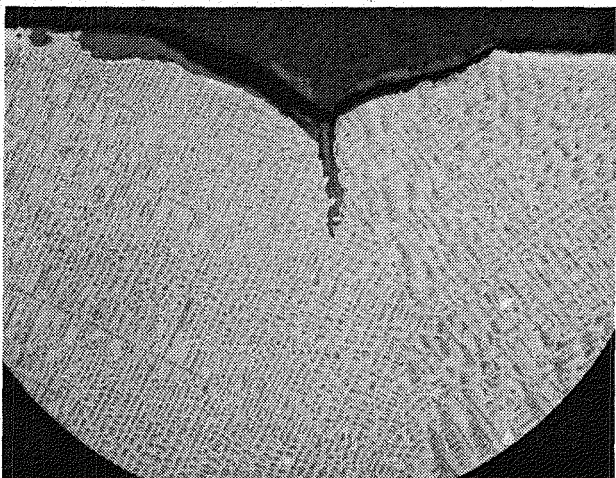
Figure 24. Typical Platform Cracks.

Convex

Concave

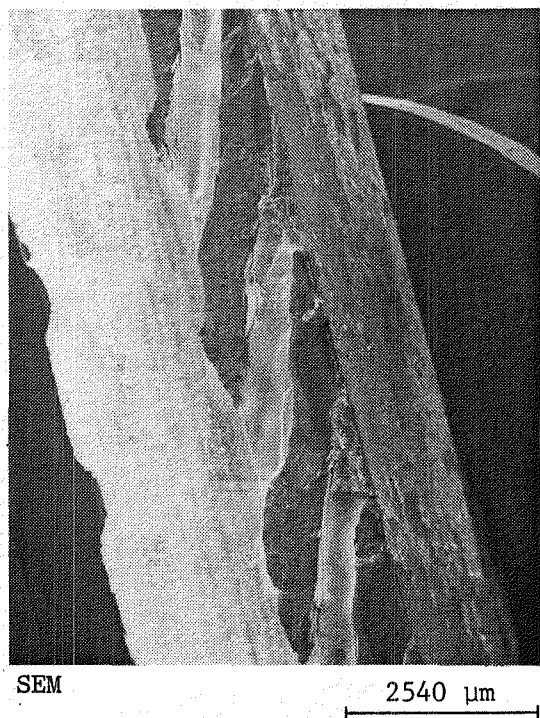
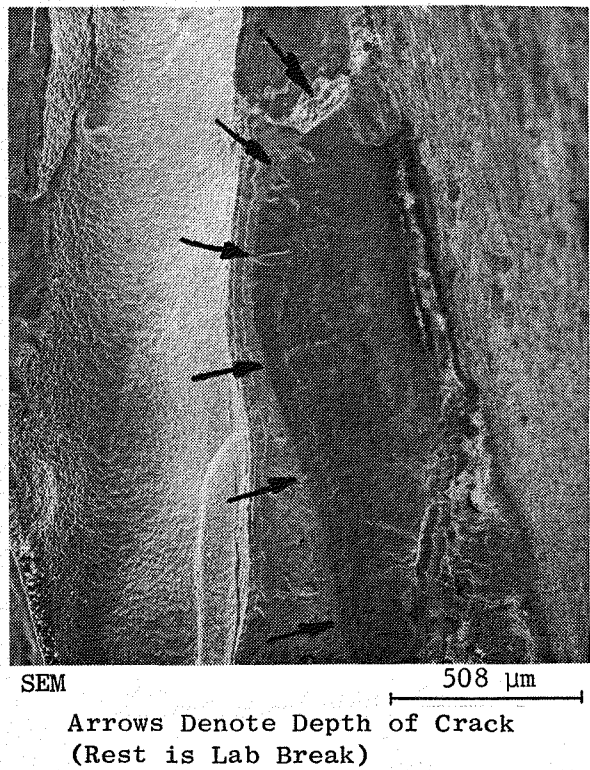
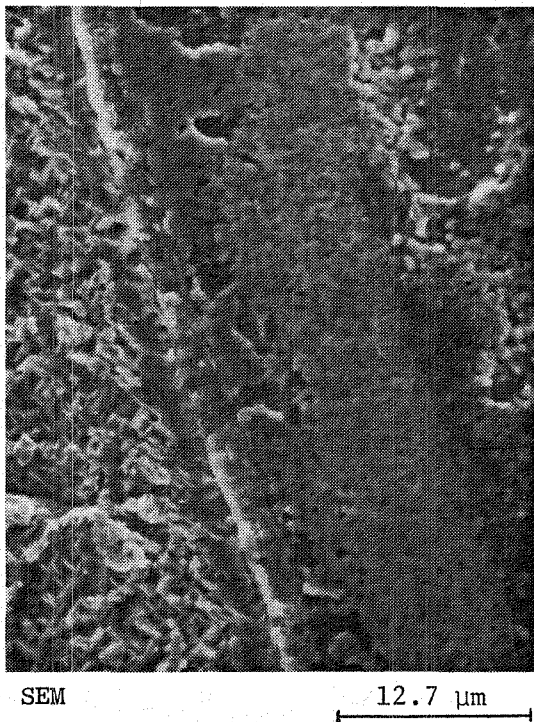
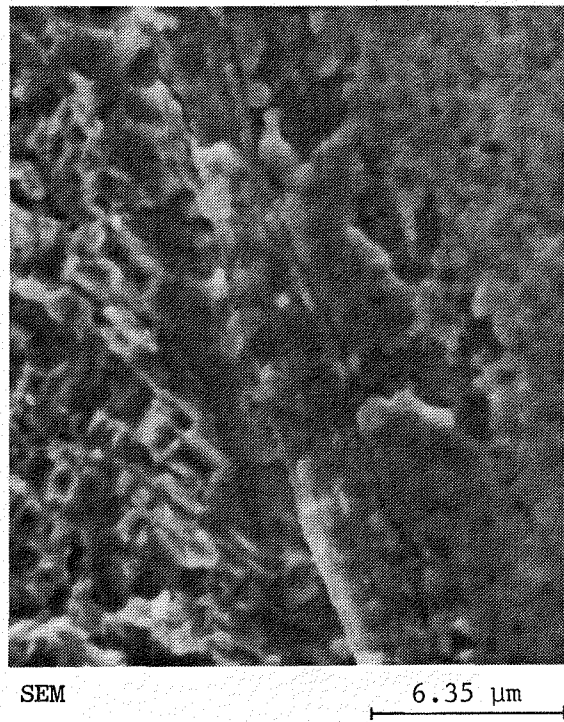
Figure 25. Scanning Electron Micrographs of Fracture Surface of Radial Pressure-Side, Film-Hole Crack.

External Airfoil Surface is to the Right; Direction of Crack Propagation is to Left. Note Evidence of Fatigue Propagation Near Crack Extremity.

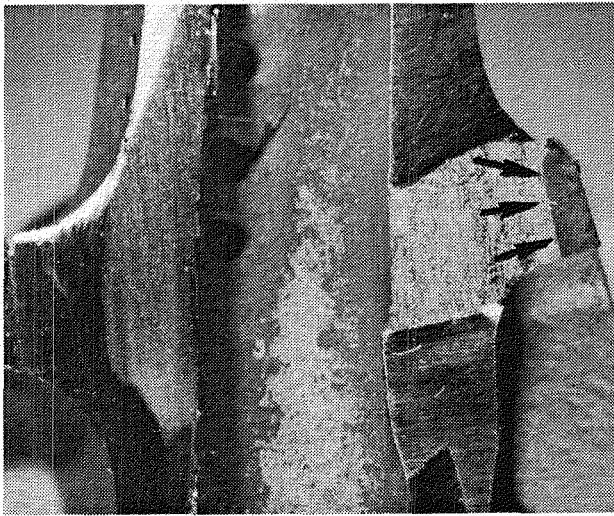
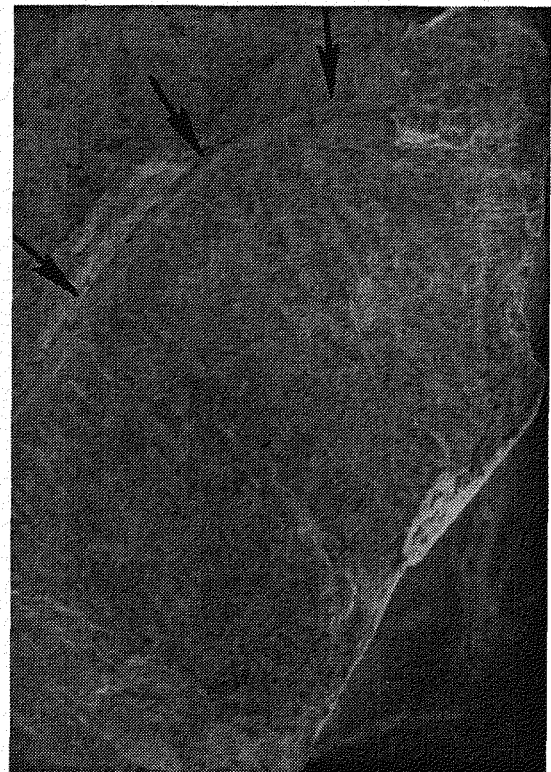
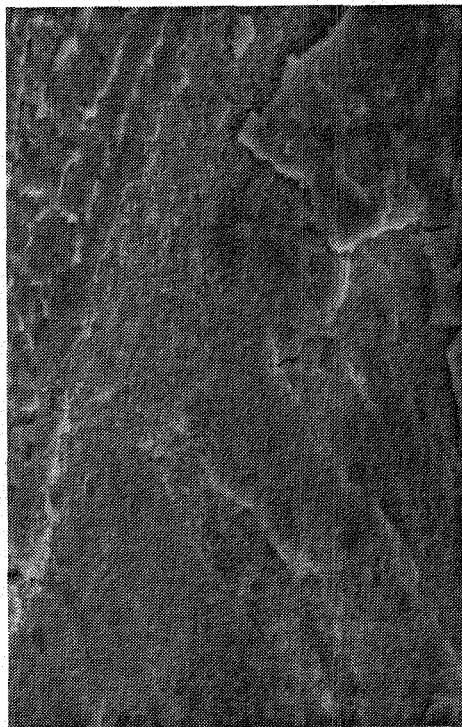
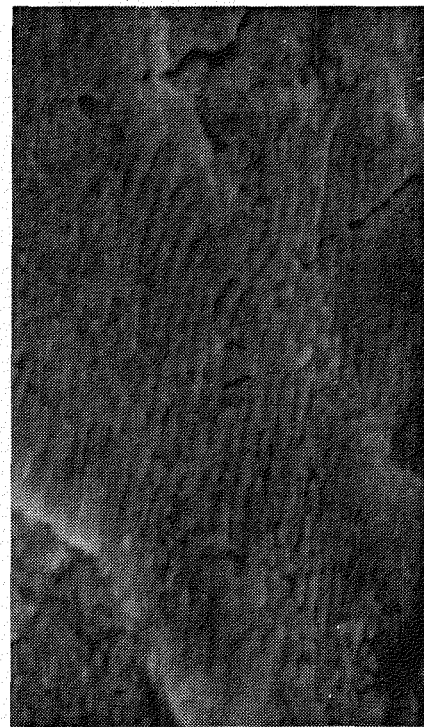
Figure 26. Scanning Electron Micrographs of Fracture Surface of a
Platform Crack.

Convex Platform Crack Fracture Surface
- Depth Denoted by Arrows (Rest is Lab
Break and Saw Cuts).

Note Evidence of Fatigue Propagation in Area of Maximum Crack Depth (Arrows).
